[AT THE STROKE OF A BRUSH:]
Painted Architecture as a Preservation Alternative

A THESIS

The Graduate Program in Historic Preservation

1994

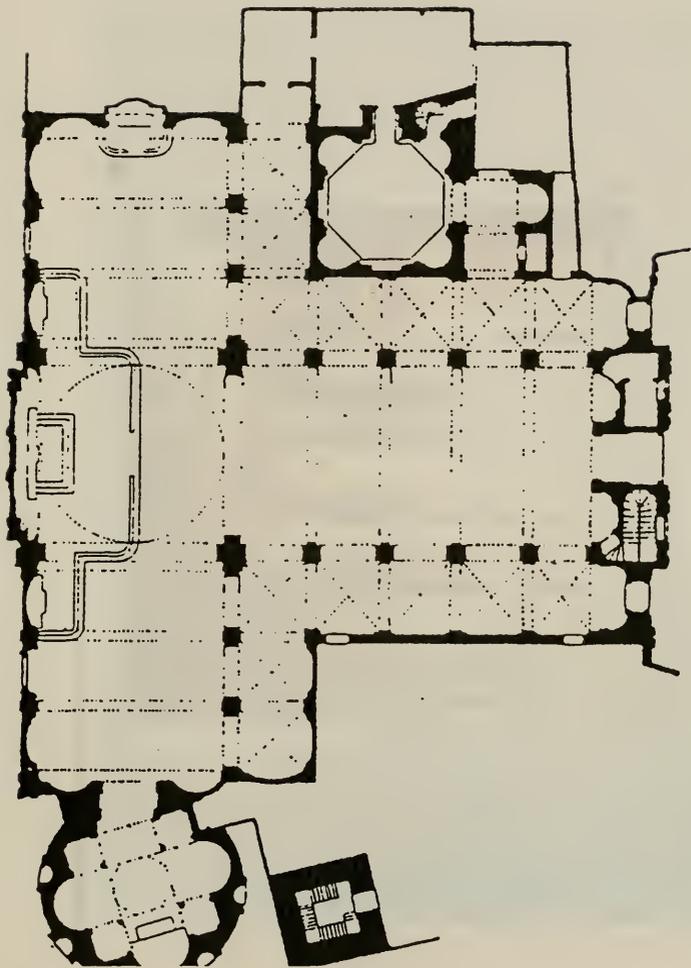
Illustration 8a: Plan of S. Maria presso S. Satiro. From M.L. d'Otrange Mastai, *Illusion in Art, Trompe L'oeil: History of Pictorial Illusionism*, (New York: Abaaris Books, 1975), 132.

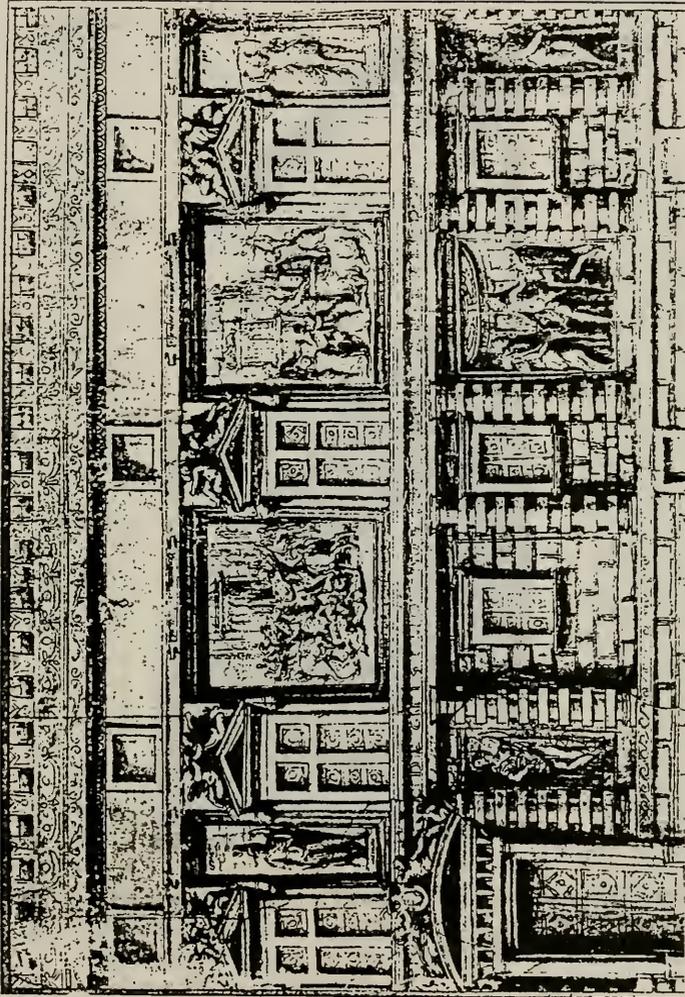
Illustration 14: Drawing for the north facade of Palazzo Doria, by Vega, circa mid-17th century. From Miriam Milman, *Trompe L'oeil Painted Architecture*, (New York: Rizzoli International Publications, Inc., 1986), 48.

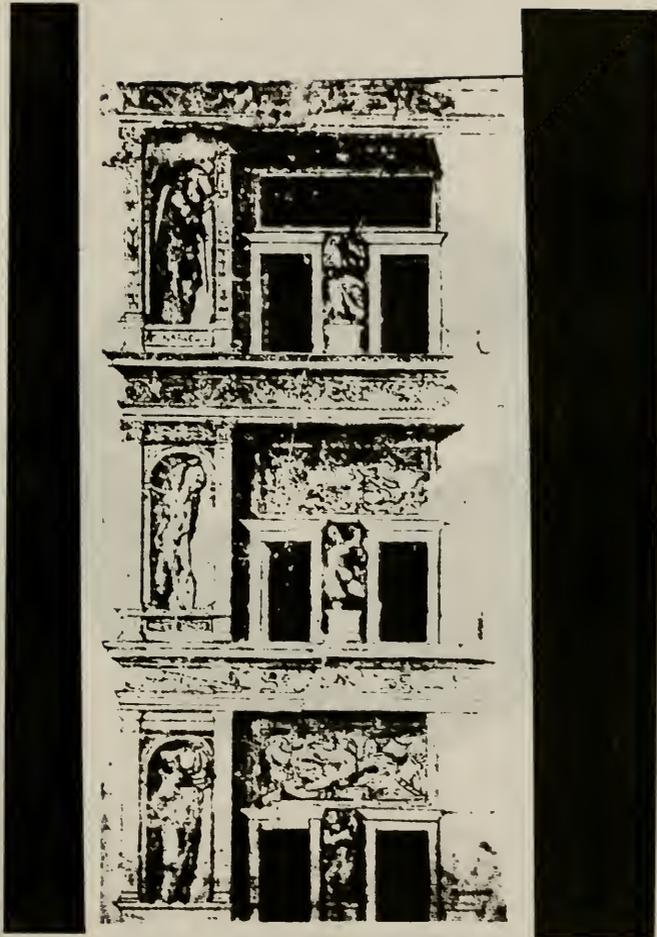
Illustration 15a: Drawing for the remodeling of "Casa dei Borghesi," by Beccafumi, circa 1512. From Erwin Panofsky, *Meaning in the Visual Arts* (New York: Doubleday Anchor Books, 1955), Pl. 59.

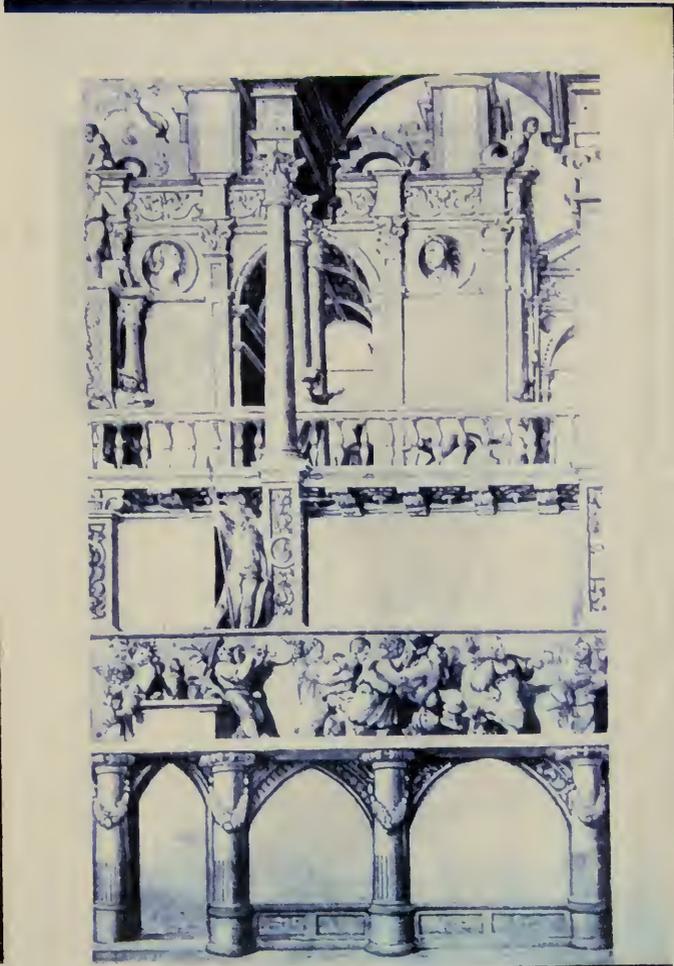
Illustration 16c: Facade drawings for the "House of the Dance" by Hans Holbein the Younger, circa 1520. From Ingvar Berstrom, *"Revival of Illusionistic Wall Painting in Renaissance Art."* (Goteborg: Goteborg Uniersitets Arsskrift, vol. LXIII, 1957), 13.

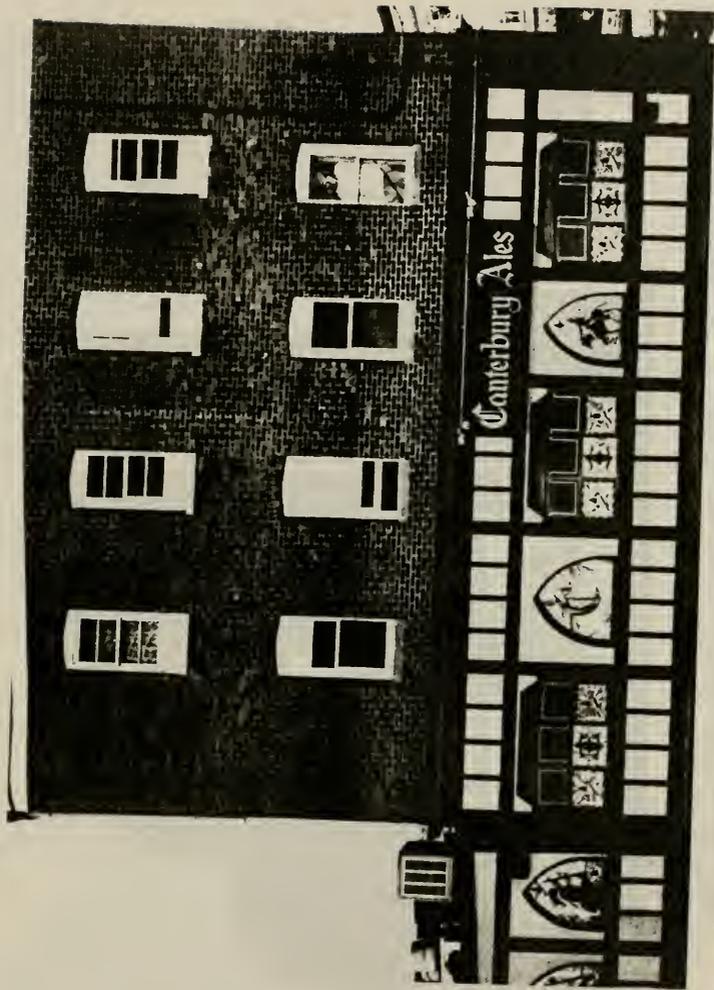
Illustration 23a: View of completed Canterbury Ales Restaurant Mural, 1982. From Lawrence Grow, *Architectural Painting* (New York: Rizzoli, 1986), 83.

Working on the project for approximately three months, Jordan's painting added six illusory windows to the two already present and created a perfect match to the building's main facade (see Illustration 23a). As a facetious touch, one of the painted windows appears open as if to flout changing weather conditions. Upon the mural's completion, the building's owner Dayna Riggs reports that the work was well received by neighborhood residents and town officials because it is seen to eliminate a long-time eyesore (see Illustration 23b).

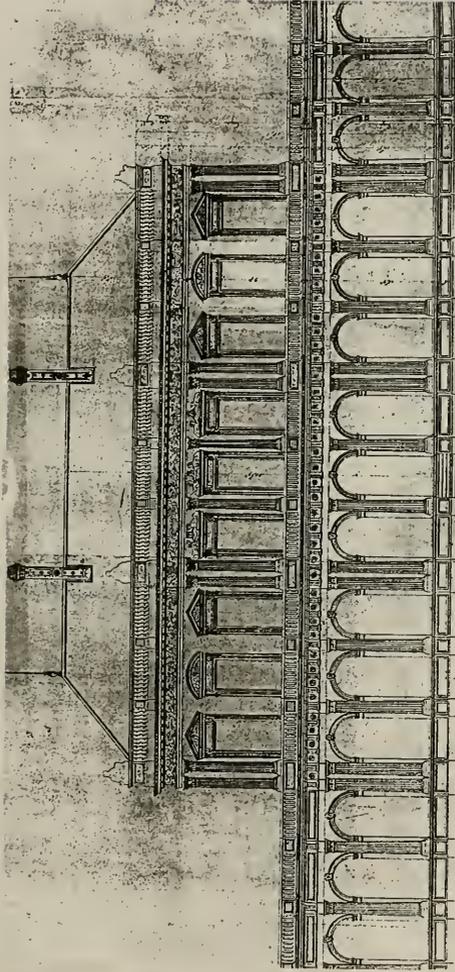
Illustration 24b: Garden elevation of "L'Hotel Pontalba," 1839. From Charles MacCallum, Louis Visconti: 1791-1853, (Paris: Delegation a l'Action Artistique de la Ville de Paris, 1991), 194.

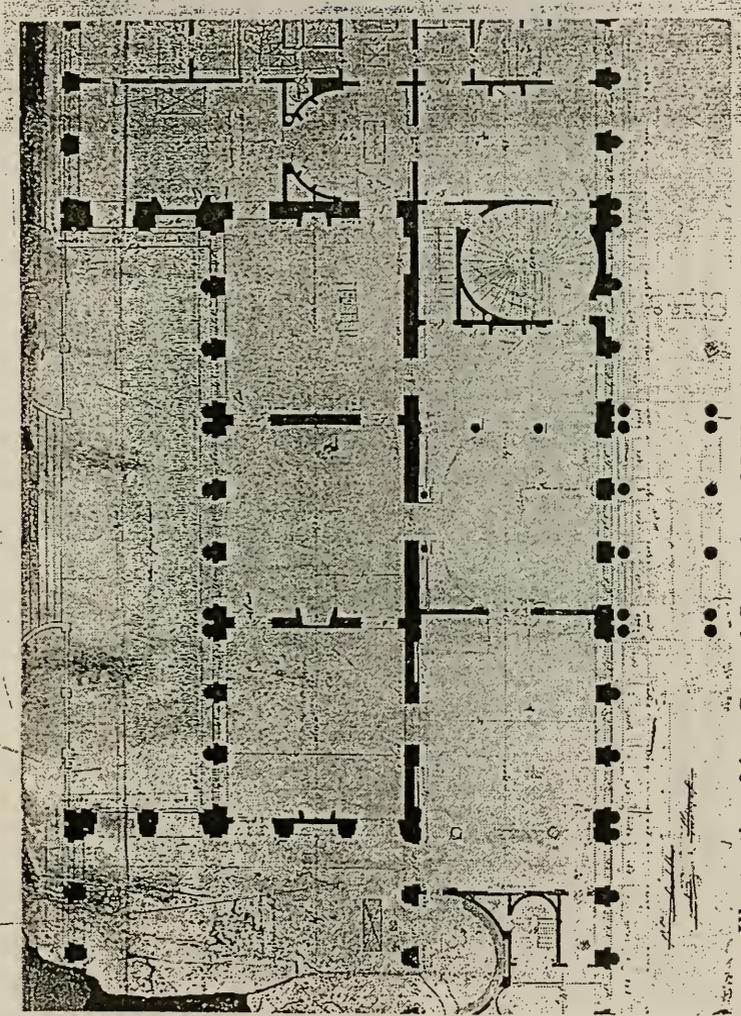
Illustration 24c: Ground floor plan of L'Hotel Pontalba, "drawn by Ludovico Visconti, 1839. From Charles MacCallum, Louis Visconti: 1791-1853, (Paris: Delegation a l'Action Artistique de la Ville de Paris, 1991), 194.

Illustrations 24b and 24c). Built on a raised podium foundation, the first floor street and garden facades were composed of an arcade utilizing paired Roman Doric order pilasters. The round arched openings incorporated elaborately carved decorative surrounds and highly ornamented keystones, surmounted by a frieze composed of triglyphs and circular cartouches. The second floor facade echoed the symmetry of the lower elevation and utilized a masonry balustrade with paired Corinthian order pilasters *en podium*. The facade was terminated by an intricately carved low-relief frieze, roof-line balustrade, and statuary. Building fenestration consisted of large casement windows with alternating pedimented and segmental-headed surrounds. The entire structure was crowned by a double-hip, side gable roof culminated by spires and four limestone chimneys.

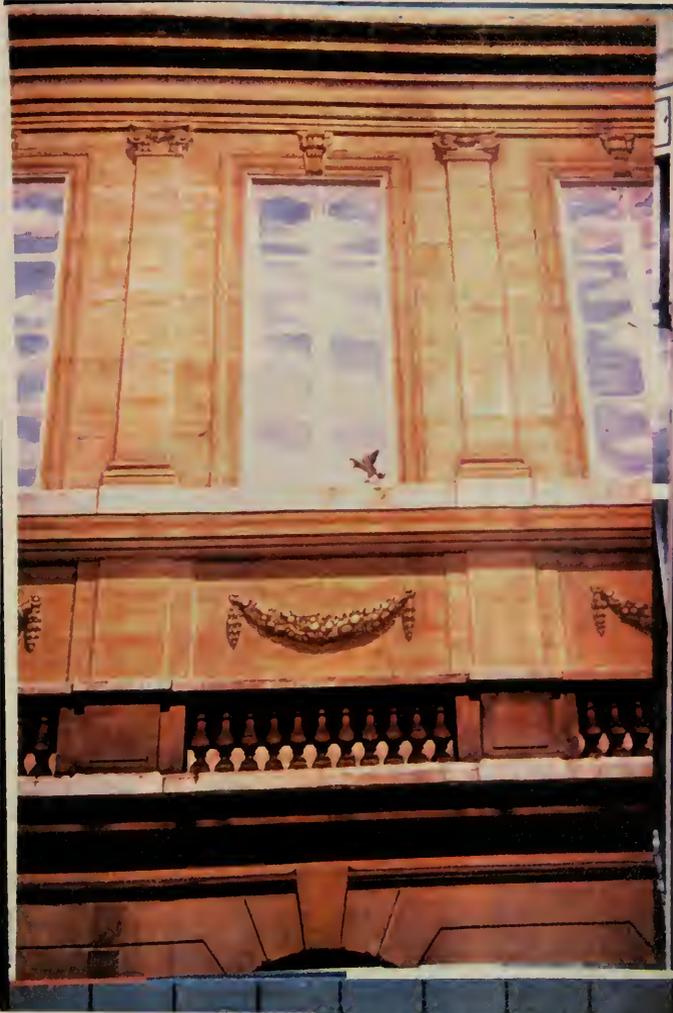
Illustration 24g: U.S. Ambassador's Residence mural (inner courtyard), Paris painted by Philip Jordan, 1983. From Lawrence Grow, *Architectural Painting* (New York: Rizzoli, 1986), 80.

The result was an effective, inviting compilation of simulated windows reflecting sky and clouds; decorative pilasters; moldings and capitals fashioned in the classicing mode of the house (see Illustration 24g). The mural's adherence to the strong architectural symmetry of the facade, without radically changing, obscuring or destroying overall building integrity serves as the foundation of its overwhelming success. Yet, even this sophisticated execution maintains a touch of capriciousness--a painted parrot perches on an imaginary window ledge.

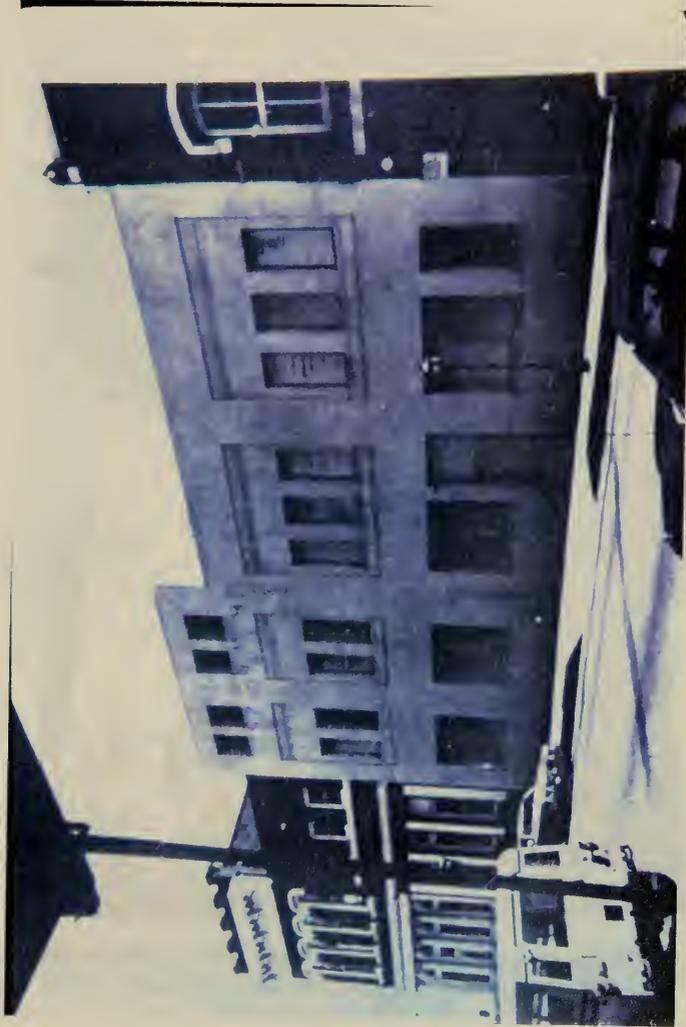
Illustration 26a: The Springer Building, 2117-2123 The Strand, Galveston, Texas, circa 1963. From Paul Goldberger, intro. *Richard Haas: An Architect of Illusion*. (New York: Rizzoli, 1981), 72.

The Springer Building, located at 2119-2123 the Strand, occupies a central site within the city block (see Illustrations 26a). The building's name comes from the Oscar Springer Company, a previous owner and the oldest printing firm in Texas until 1961.⁹⁵ Although the architect responsible is undocumented, the Springer Building was originally two separate structures. After suffering extensive storm damage in the 1940's, the two story 1878 Clara Lang Building and the adjoining 1877 Marx & Kempner Building were remodeled and combined into the present building.⁹⁶ Composed of brick construction, the entire south facing street facade is rendered in plaster.

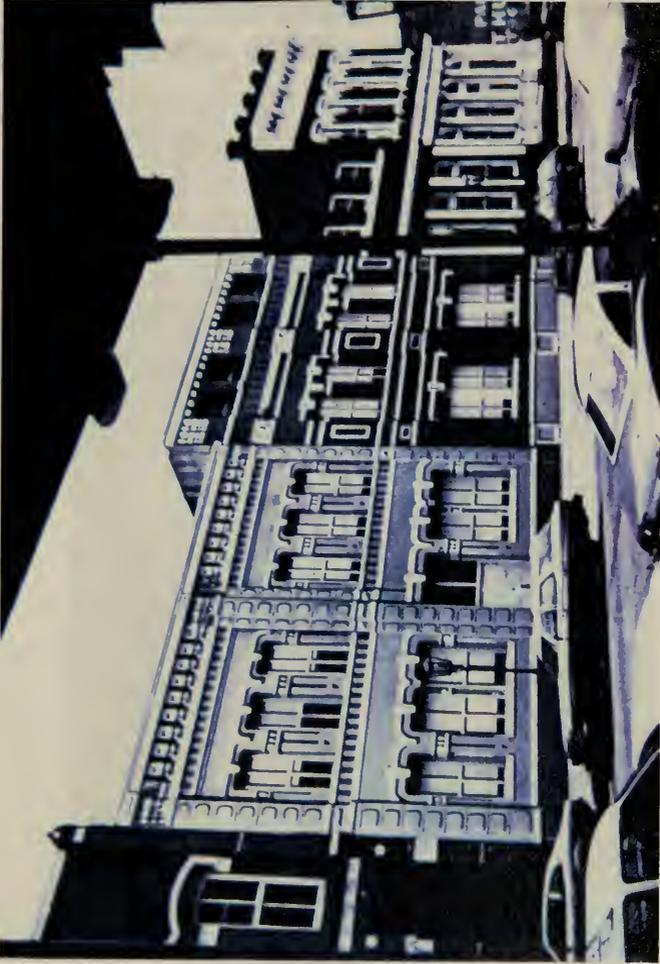
Illustration 26c: The Springer Building Mural, 1976. From Paul Goldberger, intro. *Richard Haas: An Architect of Illusion*. (New York: Rizzoli, 1981), 73.

Haas's final design was a combination of architectural elements from his own imagination, neighboring structures, and those used by Nicholas J. Clayton, who was Galveston's leading architect during the late 19th century. Determined as an extremely successful venture by all parties involved, the Galveston Historical Foundation got more than just a pretty painting for \$17,000. The mural became a sound investment towards the stabilization of the city's vital historic district, and the visual re-incorporation of a building that was perceived as no longer architecturally significant by the area's preservation community (see Illustrations 26b). Today, the structure serves as a luxury apartment building. Although the physical condition of the mural has remained intact over the past eighteen years with only minor touch-ups, it has faded slightly (see Illustration 26c).

Richard Haas's *Springer Building Mural* in Galveston, Texas, partially illustrates this concept (see again Illustration 26c). His research into the building's historical appearance yielded evidence that it was originally constructed as two separate structures. The use of historic photographs allowed Haas to re-interpret and respect general building forms in his mural design. Unfortunately, that was the extent of his findings. According to Peter Brink, the former executive director of the Galveston Historical Foundation, documentation consulted for the Springer Building was limited to two old photographs taken at distorted angles which proved to be insufficient in determining conclusive evidence of the building's original countenance.¹⁰⁵ These inconclusive data made all restorative attempts virtually impossible, therefore, the project goal

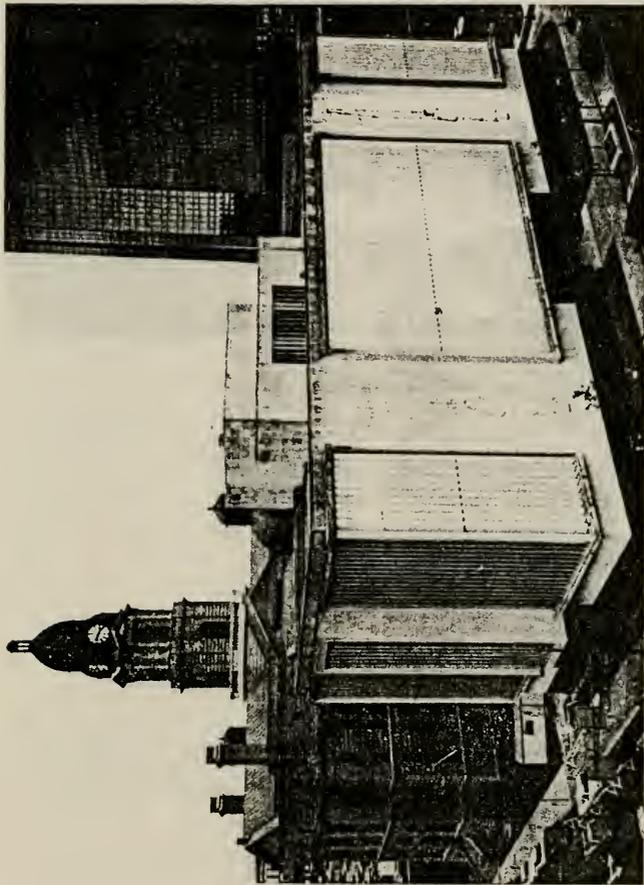
Illustration 27f: Original 1906 elevation blueprint of the Heidelberg (Crossroads Building) by Henry Ives Cobb. From Paul Goldberger, intro. *Richard Haas: An Architect of Illusion*. (New York: Rizzoli, 1981), 99.

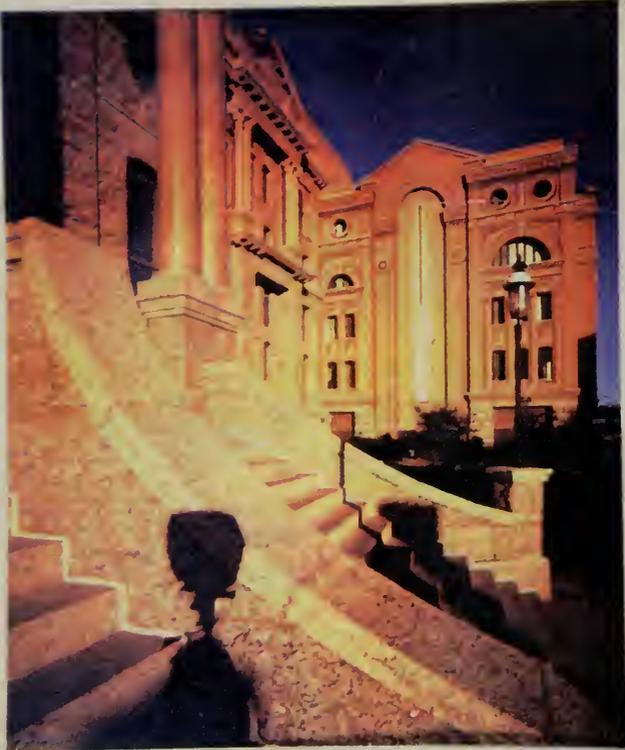
Illustration 28a: View of exterior pre-fabricated panel system of the Tarrant County Courthouse Annex, 1988. From Martin Filler, *Richard Haas Architectural Projects 1974-1988*, (New York: Alexander Hoffman Gallery, 1988), 17.

Similar in execution to that observed in the *Tarrant County Courthouse Annex Mural* case study in Chapter Two, this experimental design would use the same material (Dryvit) as the intermediary paint surface. Technical questions relating to design feasibility and construction, were addressed to the Dryvit manufacturer and several structural engineers. As a suitable solution, I discovered that Dryvit is a lightweight, and durable synthetic stucco panel system designed especially to be used as an exterior insulation and surface finish. The strongest advantages offered by Dryvit are the cost-effectiveness and energy-efficiency of using this material as an alternative to conventional construction methods involving many retrofit projects.

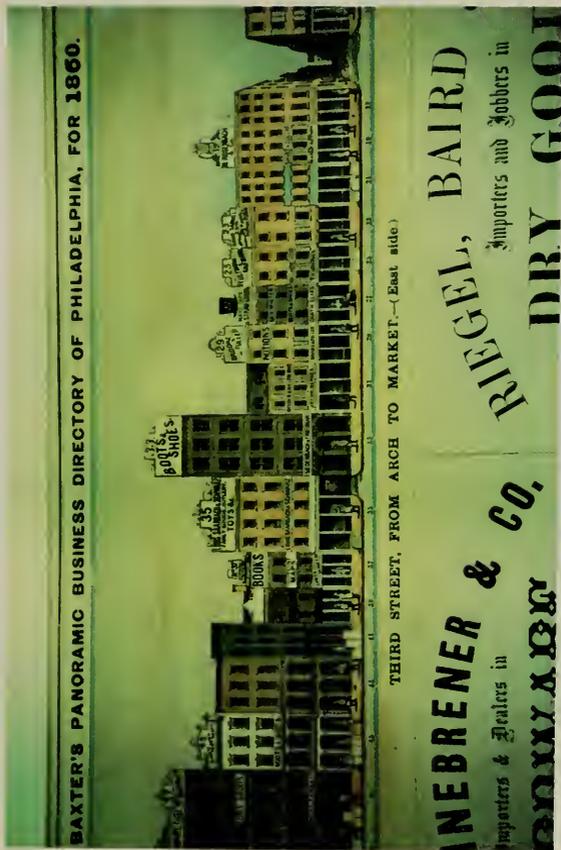
Illustration 30: Engraving of 29 North Third Street, Philadelphia, Pennsylvania by Charles B. J. Saint-Memin, circa 1801. From the Cambell Collection, vol. 89, The Historical Society of Philadelphia, Pennsylvania, 65.

Despite the limited amount of written information on the building, appropriate graphic documentation was retrieved to determine the building's original countenance. The earliest graphic evidence found was an engraving of the building by Charles Saint-Memin, dated 1801 (see Illustration 30). The engraving appears to be an accurate rendering, yet, there is some degree of uncertainty regarding the engraving's date. A handwritten note found on the archival copy serves to verify the drawing's execution. The year does coincide with the time Saint-Memin lived in Philadelphia before returning to France in 1810, but the architectural detailing of the building's elaborate cornice and bracketed balconette implies a much later building construction date -- post 1840.

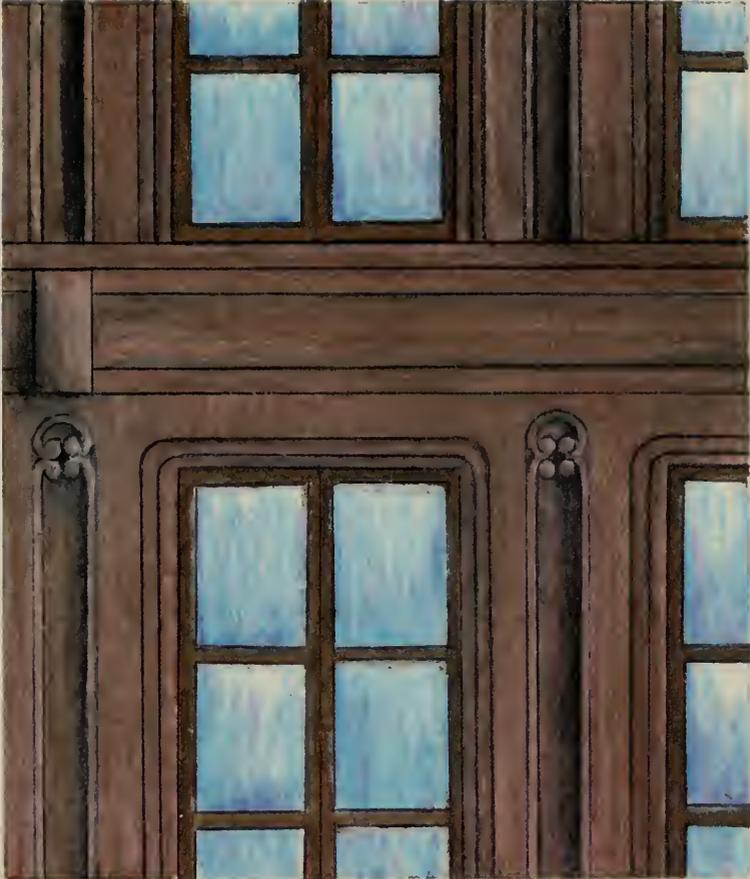
Illustration 31: Sketch of proposed facade mural for 33 North 3rd Street, Philadelphia, Pennsylvania, 1994. Drawn by Derek Satchell.

The design concept of this experiment involves the painted replication of the building's brownstone facade upon an intermediary surface. By utilizing this concept, it preserves the historic underlying material for future re-interpretation. Painted architecture could have been utilized as a permanent preservation solution by physically removing the building's deteriorated surface, and painting an image directly upon the unstable material substrate. Yet, this alternative is in contraction to the Secretary of the Interior's guidelines for utilizing the least destructive rehabilitation means as possible. Instead, I determined that if the historic fabric could be stabilized (based upon physical examination), the facade would be encased by an applied, non-destructive and protective surface on which a painted facsimile of the underlying facade could be employed. As

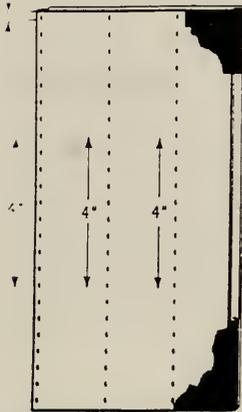
STAPLES TO WOOD FRAMING*
(16" OR 24" O.C.)

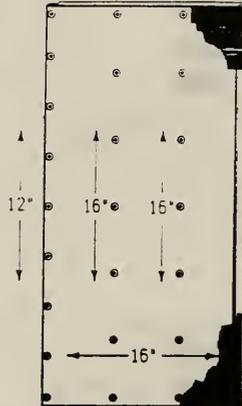
SCREWS & WASHERS TO WOOD/STEEL FRAMING* (16" O.C.)

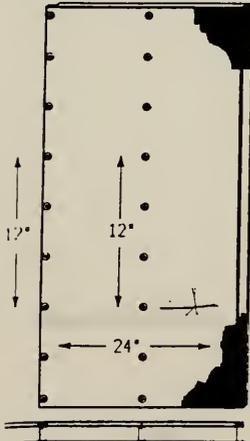
SCREWS & WASHERS TO MASONRY, WOOD/STEEL FRAMING (24" O.C.)*

PLAN SECTION

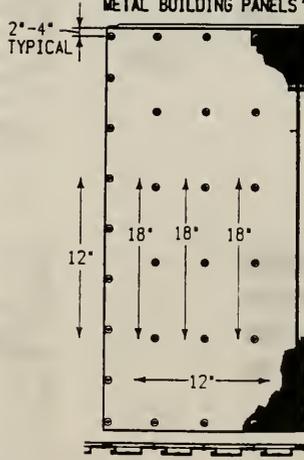
Figure No. 1

SCREWS & WASHERS TO METAL BUILDING PANELS*

PLAN SECTION

* When Butt Joints are specified, each board must be fastened separately

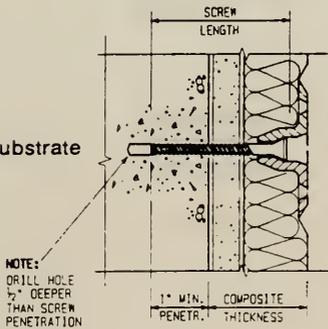
Masonry Substrate

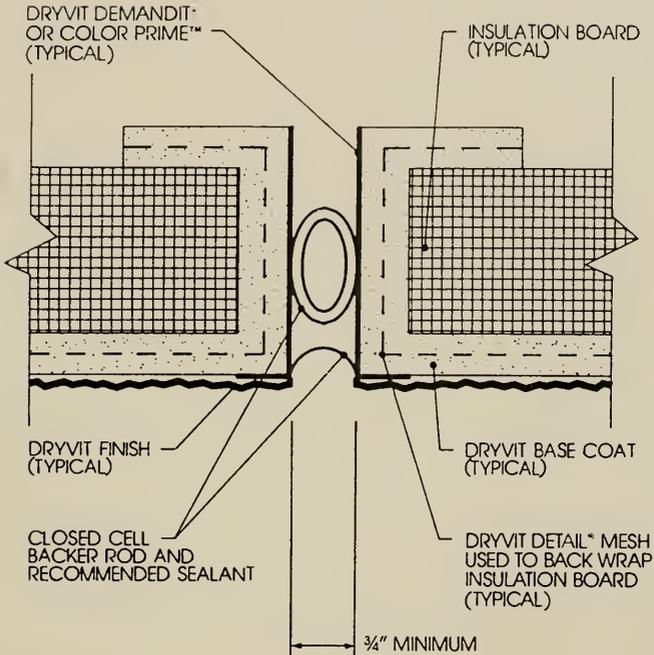
Joint Detail

- DEMANDIT OR COLOR PRIME WILL BE APPLIED INTO THE JOINTS PRIOR TO APPLYING FINISH COAT TO THE FACE OF THE WALL.
- DEMANDIT WILL BE COLOR MATCHED TO THE FINISH AND WILL EXTEND ONTO THE FACE OF THE WALL.
- IF THE SEALANT IS RECESSED, THE FINISH MUST BE BROUGHT TO THE FACE OF THE SEALANT.
- SEALANT MUST COVER ALL TRANSITIONS BETWEEN THE FINISH COAT AND DEMANDIT.
